# Montecito Sanitary District

### STAFF REPORT – 3A

**DATE:** January 17, 2024  
**TO:** A&O Committee  
**FROM:** John Weigold, General Manager  
**SUBJECT:** Discuss Seismic Risk Assessment and Evaluation

# Seismic Risk Assessment and Evaluation

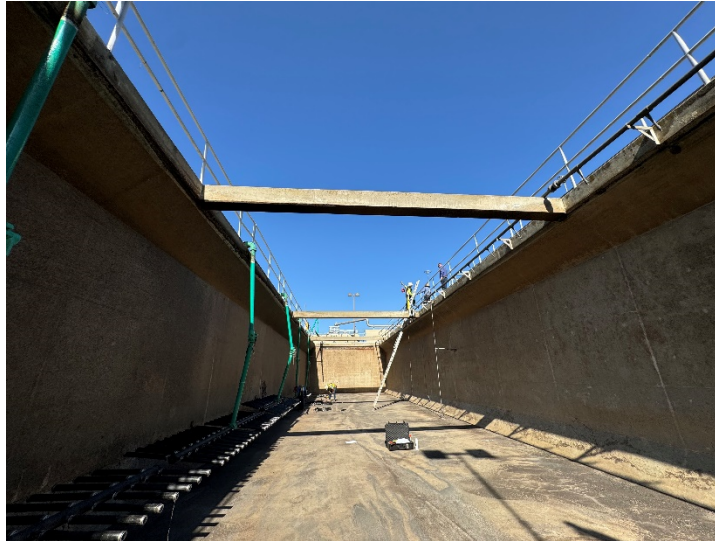
Figure 5

Aeration Basin 1 was observed on August 6, 2024. Cores were taken in the North, East, and West walls and in three locations in the slab. The locations were selected to ensure protection of Basin 2 that remained operational during coring.

Cracking on the surface of the walls is prevalent. The crack pattern is generally random with a combination of vertical, horizontal, and diagonal cracks. Cracks in the walls range from hairline to 0.030-inches. There is no significant offset across the cracks.

North Wall: The north wall has diagonal cracks starting from the bottom corners indicating possible shrinkage cracks due to restraint at the foundation. The diagonal face of the haunch at the top of the walls has a consistent horizontal crack

South Wall: There are frequent cracks and no evidence of moisture seeping through cracks from Aeration Basin 2 which was in operation at the time of observation.

East & West Walls: Numerous cracks across surface. Not significant in width at the surface, but very frequent with an irregular pattern. There is heavy corrosion in the steel plate at the weir at the west wall.

**Concrete Beams:** Across the top of the basin are three concrete beams spanning from wall to wall. Each of the beams has significant cracks which can be observed in photos 08, 09, and 10 of Appendix D.

**Slab:** Generally, the slab in good condition. No major cracks visible at the surface, however some dry tank contents were present along the floor during observation which limited visibility.

**Walkways:** The surface of the walkways and tops of the walls has frequent cracking. Cracks range from hairline to 0.10-inches.

The most significant observation was made during coring. All cores indicated there is a vertical crack plane in the walls that is 4 to 5-inches from the wall surface. This is discussed further in the Summary for the In-Ground Concrete Structures.

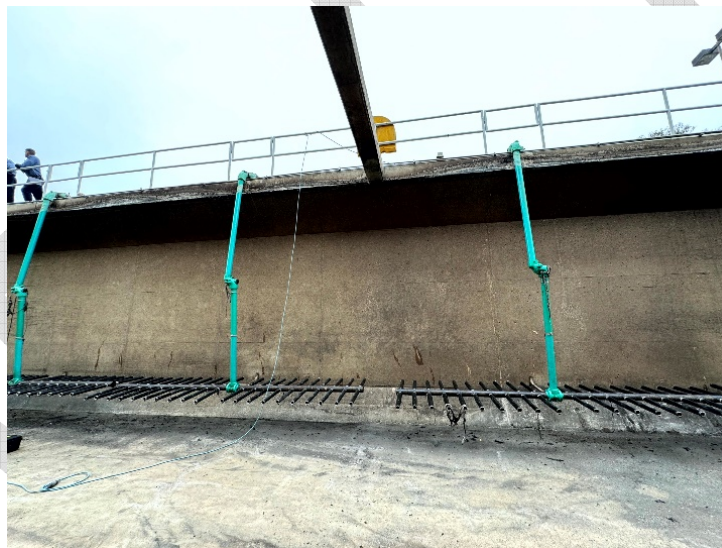
*Figure 7*

Aeration Basin 2 was observed on August 28, 2024. Cores were taken in the South, East, and West walls and in three locations in the slab. The divider wall between Aeration Basin 1 and 2 was not sampled. The locations were selected to ensure protection of Basin 1 that remained operational during coring.

Cracking on the surface of the walls is prevalent. The crack pattern is generally random with a combination of vertical, horizontal, and diagonal cracks. Cracks in the walls range from hairline to 0.030-inches.

North Wall: The north wall has exposed aggregate at the face of the wall at the east end. At a distance of 3 to 6-feet above the top of slab there were multiple vertical cracks with apparent moisture in the crack. It was inconclusive if this moisture was coming from the operating Aeration Basin 1.

South Wall: Similar to the north wall of Aeration Basin 1, the south wall of Basin 2 has diagonal cracks starting from the bottom corners indicating possible shrinkage cracks due to restraint at the foundation.

East & West Walls: Numerous cracks across surface. Not significant in width at the surface, but very frequent with an irregular pattern. There is heavy corrosion in the steel plate at the weir at the west wall.

Concrete Beams: Across the top of the basin are three concrete beams spanning from wall to wall. The western most beam has an exposed piece of reinforcing at the top of the beam. All beams have cracks along the exposed faces.

Slab: Generally, the slab is in good condition. Hairline cracks are present, but no major cracks visible at the surface, however some dry tank contents were present along the floor during observation which may have concealed additional cracks.

Walkways: The surface of the walkways and tops of the walls indicates significant cracking.

Similar to Aeration Basin 1, the vertical crack plane is present in the sampled concrete walls.

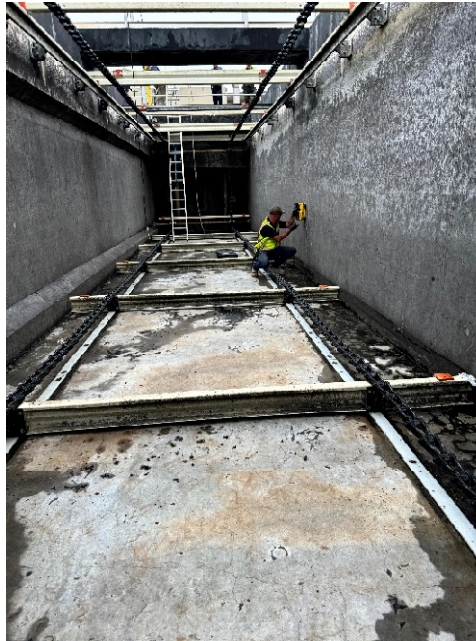
*Figure 10*

Clarifier 2 was observed on August 28, 2024. Cores were taken at the top of the south divider wall between Clarifiers 1 and 2, in the face of the north divider wall between Clarifier 2 and 3, and at the slab.

**North Wall:** Visual observation indicated cracks in the north wall are frequent and in many different directions. The largest cracks, 0.025-inches, are horizontal at around 4 to 6-feet above the slab level.

**South Wall:** Some small cracks visible, but coating is concealing most of the wall. If frequent cracking on the surface is present, it's anticipated they are small as the crack has not propagated across the coating.

**East Wall:** Cracking in the east wall is frequent. There are some large horizontal cracks exceeding 0.03-inches on the face of the wall. There was no apparent liquid transmission through the crack from the operating chlorine contact tank on the opposite side of the wall.

**West Wall:** Due to the depth of the channel at the west side of the clarifier the wall was only observable from 6-feet away. No major cracking is visible.

**Slab:** The slab of clarifier 2 has extensive cracks. They vary from hairline to 0.02-inches. The coating on the slab is no longer present as the sludge collector mechanism has rubbed it away.

Walkways: There is extensive cracking in the walkways around the clarifiers.

Cracking internal to the concrete walls was found in the concrete cores sampled.

Petrographic Examination: Alkali-silica reaction present

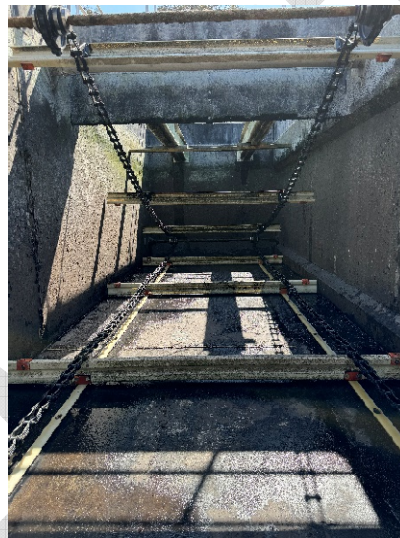
Figure 11

Clarifier 4 was observed on August 7, 2024. Cores were taken in the north wall and in the slab. The failed coating on the interior of the walls limited the observation of the concrete surface.

Walls: Some hairline cracks are present in the walls. Cracks have not propagated through the coating as it did in Clarifier 2.

Slab: Generally, the slab is in good condition. There are some small hairline cracks, but no major cracks are present.

Walkways: North of the Clarifier 2 the walkways have some cracking, but it is not as extensive as the original clarifier construction.

The vertical crack plane was found in the concrete cores sampled.

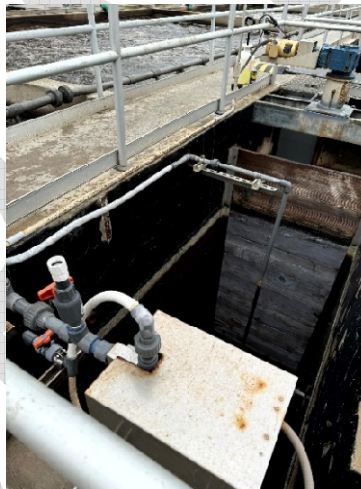
*Figure 13*

Chlorine Contact Tank 1 was observed on August 30, 2024. Cores were taken in interior divider wall only.

**Walls:** Cracking in the walls is very frequent. Large cracks 0.03-inches to 0.05-inches were observed inside the basin.

**Slab:** Due to limited time for testing, the slab was not dry and had standing water that was 2 to 3-inches deep. No major cracks were observed in the slab.

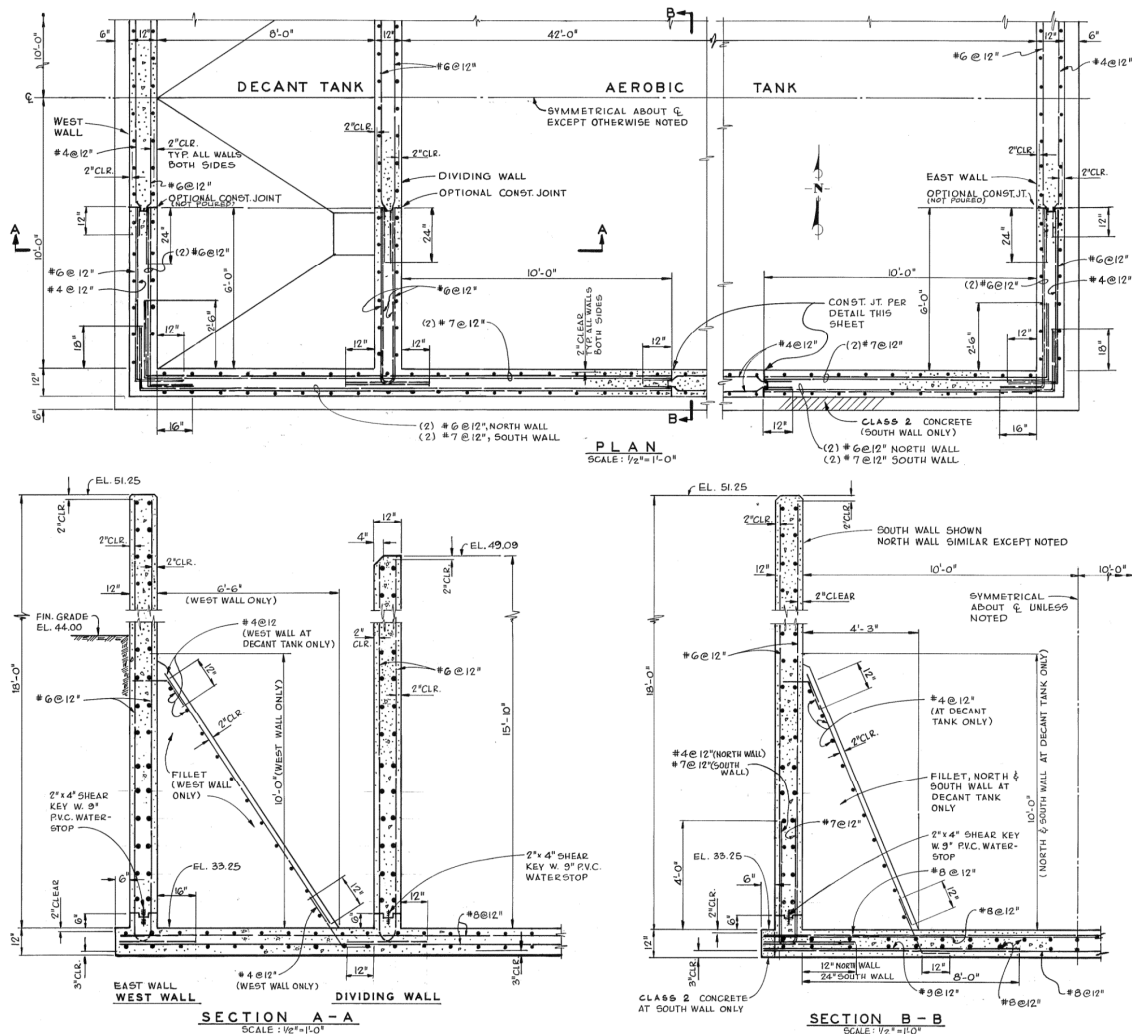
Figure 14

Concrete of the south section of the Aerobic Digester was observed and sampled on August 28, 2024. Samples were taken from two walls in the sections above grade. Cores were taken in the slab in two locations.

**Walls:** Generally, the walls were in good condition with some cracks. The quantity of cracks was minimal when compared to the other concrete structures.

**Slab:** During the observation, the bottom of the slab had dry sludge making the entirety of the slab difficult to observe. The areas that were exposed were in generally good condition with minimal to no cracking.

The vertical crack plane that was present in the other concrete structures was not identified in the Aerobic Digester walls or slab.

The Aerobic Digester is in good condition. It is recommended to add a water-proofing coating to the surface of the Aerobic Digester as an additional protection to the concrete surface and reinforcing. Testing for ASR is scheduled for this structure.

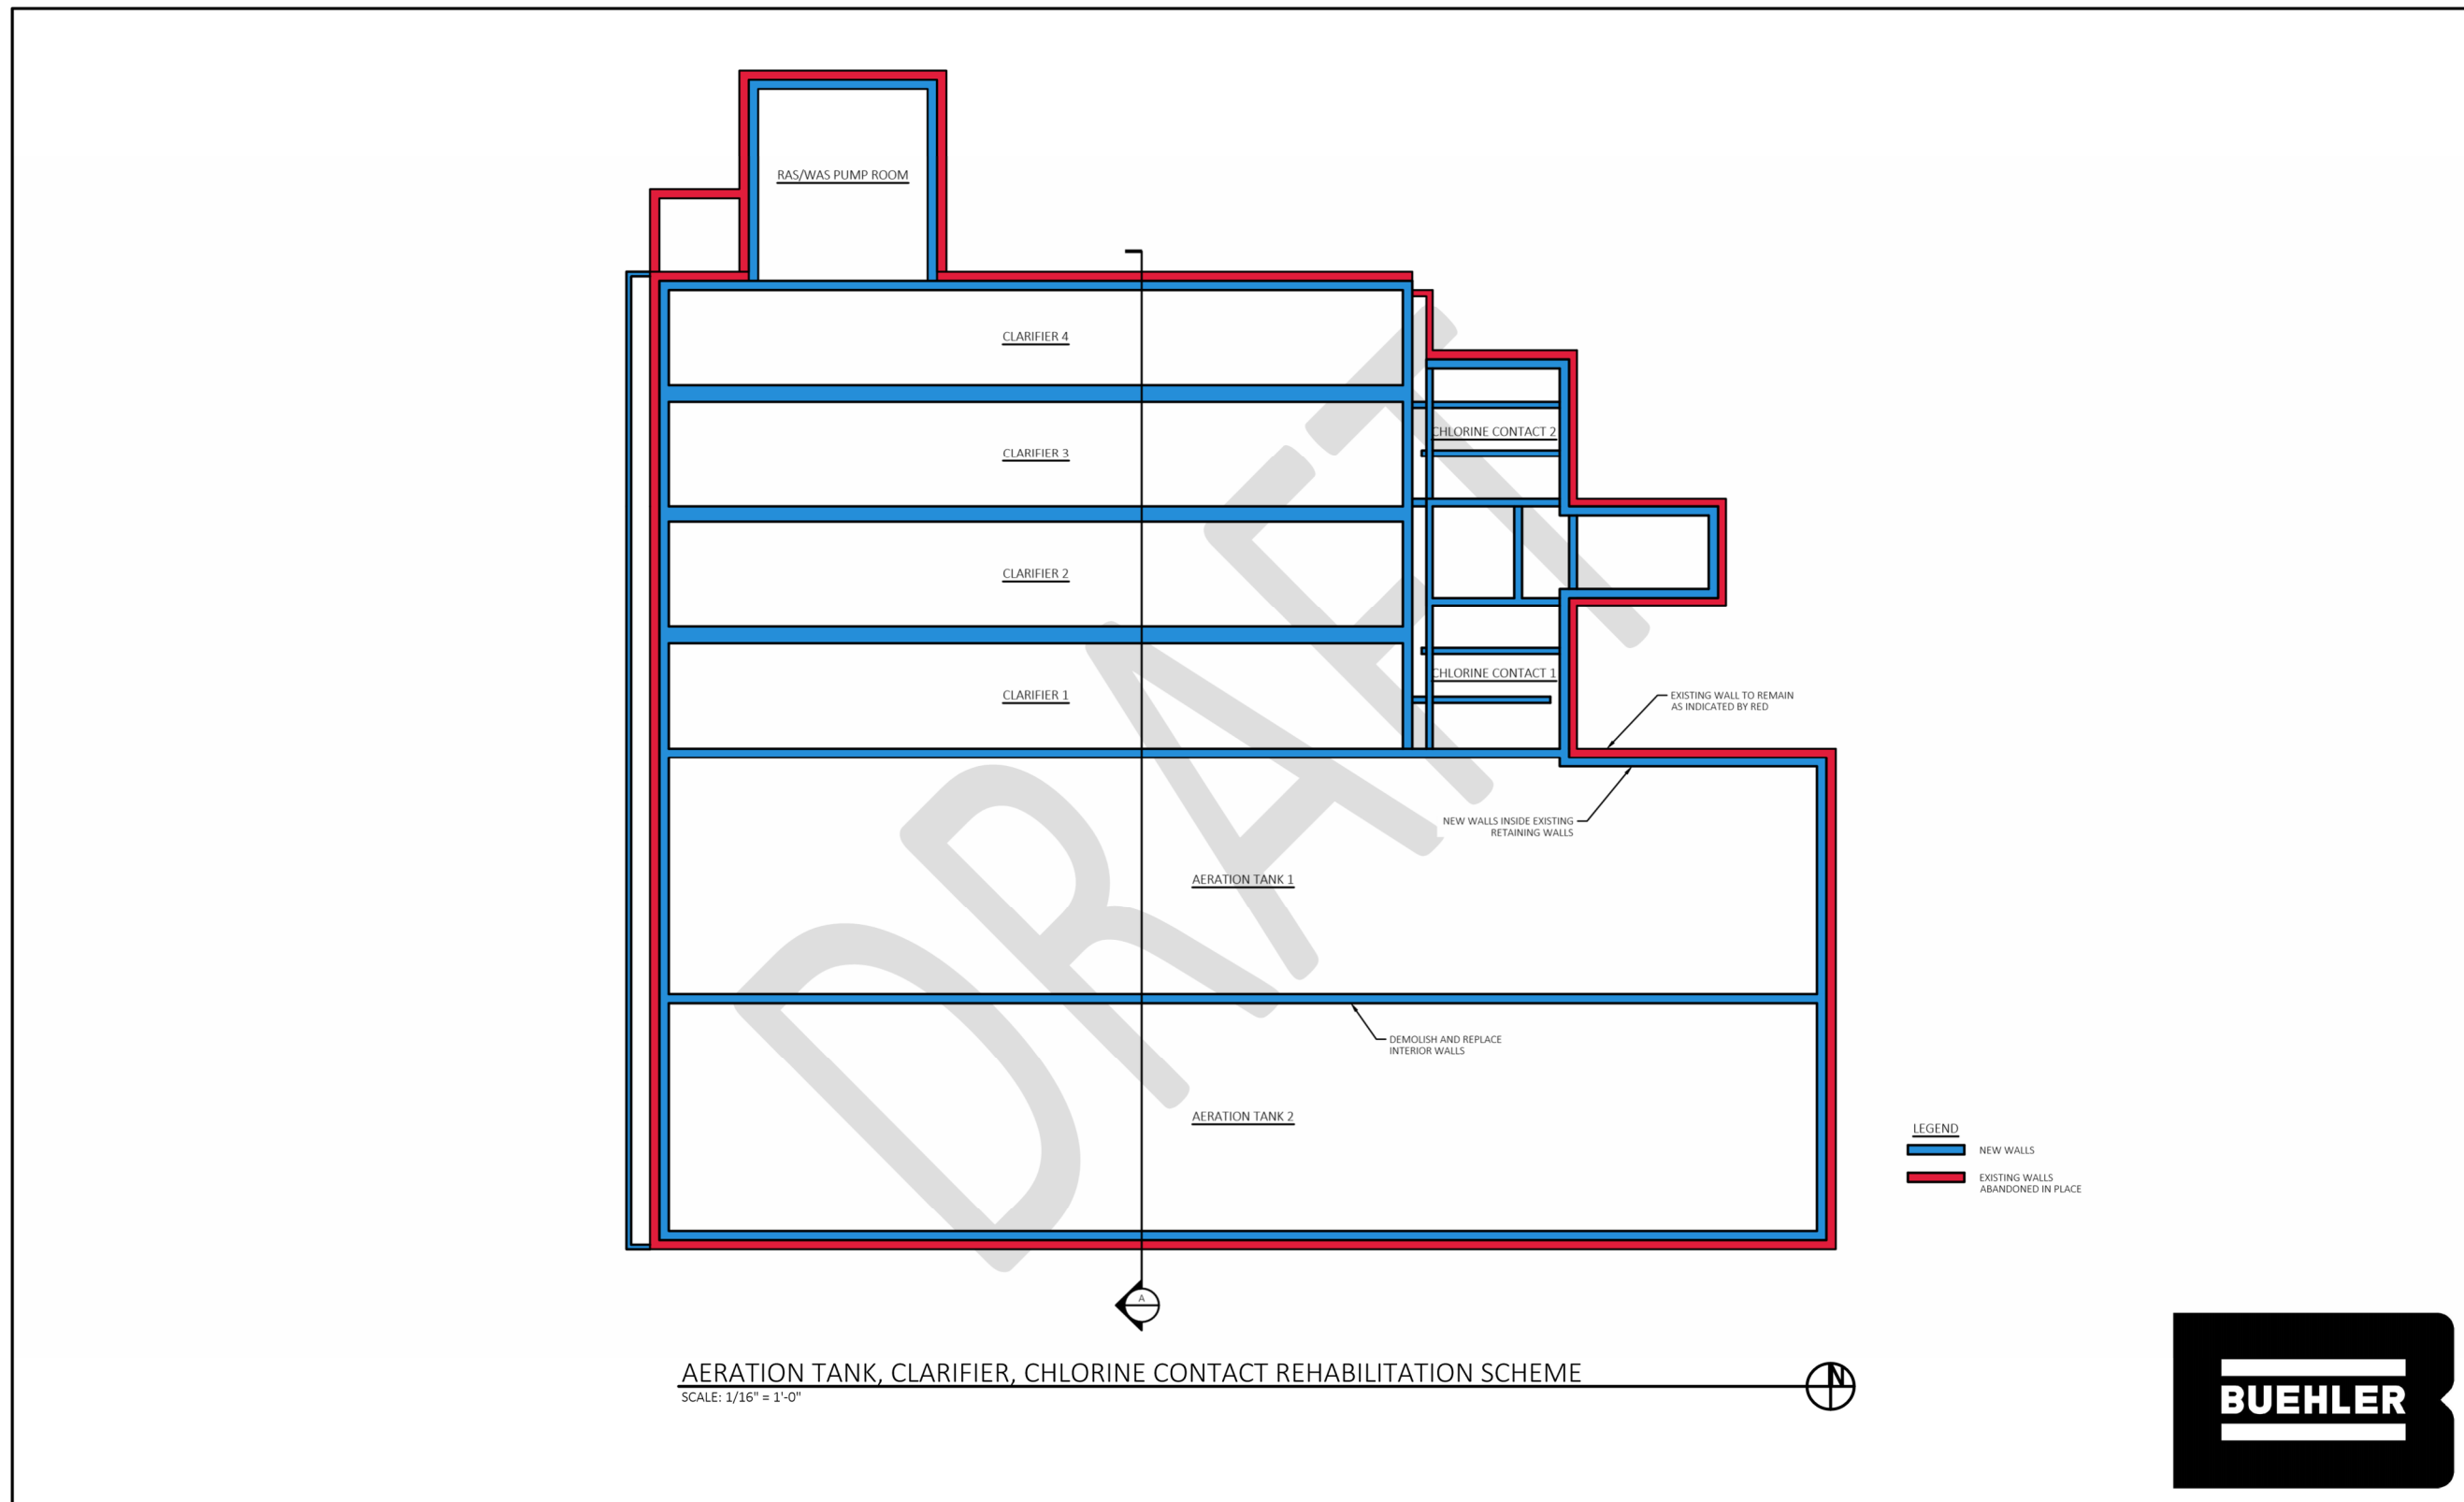
The presence of the vertical crack plane in the concrete walls and the regularity in which it occurs is concerning when considering the future service life of the existing buried and liquid containing structures. This crack was present in all buried structures except for the Aerobic Digester. From a structural perspective, this crack is problematic because the wall section no longer acts as one continuous element. Rather the forces are resisted by two thin walls. Any composite action between the two sections relies on aggregate interlock across the crack plane. Significant failure

While there has not been a failure in terms of a partial collapse or noticeable loss of tank contents, the cracking is indicative that the in-ground tank structures are at the end of their Technical Service Life. The recommendation for the future service life of the Aeration Basins, Clarifiers, Chlorine Contact Tank, RAS/WAS Pump Pit and Dry and Wet Wells is full replacement of the existing structures.

An alternative to full replacement is to selectively demolish portions of the existing structure and cast new concrete slabs and walls inside of the existing structures. This would allow the existing piping to the plant to remain in operation. To keep the plant operational during construction, consideration of sequencing would be required which may extend the construction timeframe for full rehabilitation of the plant. See Figure 17 for conceptual plan of structural rehabilitation.

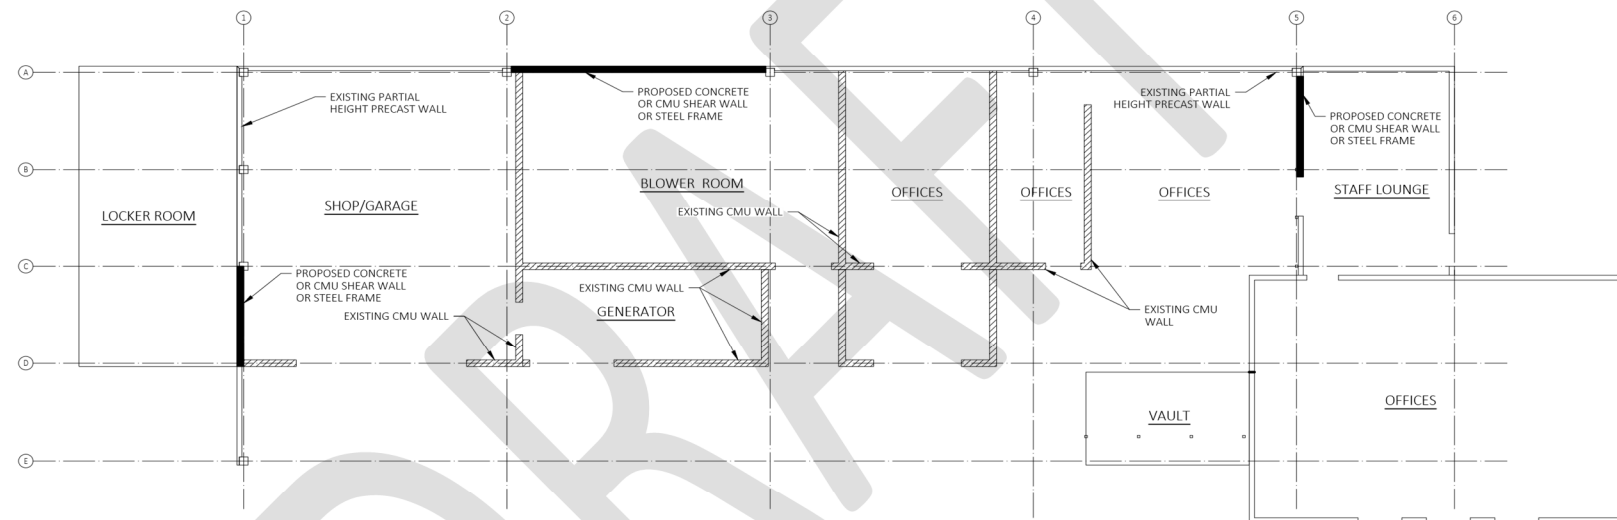
While there are two lines of lateral systems in each direction, the clerestory windows above the precast panel do not allow for diaphragm shear transfer of lateral loads to the concrete wall. The configuration of the CMU lateral system results in an offset in the buildings center of mass and center of rigidity which results in an extreme torsional irregularity. This irregularity may result in failure of the 10-inch square concrete columns at the north and east walls when subject to seismic loading and displacement.

The anchorage of the CMU walls is inadequate for out of plane wall loads for the eave wall condition. The current attachment relies on torsion of the wide flange beams to support them for out of plane loads. The limited horizontal reinforcing in the CMU walls does not allow the CMU walls to span to perpendicular walls.

To provide adequate CMU wall anchorage, it is recommended to add out of plane ties for the CMU walls. This can be done by adding epoxy anchors to the tops of the walls and steel plate attachments to the diaphragm. Steel waler beams can also be used to brace the tops of the walls. See Figure 19 for a conceptual rehabilitation plan.
