# Montecito Sanitary District

### STAFF REPORT – 3A

**DATE:** January 17, 2024  
**TO:** A&O Committee  
**FROM:** John Weigold, General Manager  
**SUBJECT:** Discuss Seismic Risk Assessment and Evaluation

# Seismic Risk Assessment and Evaluation

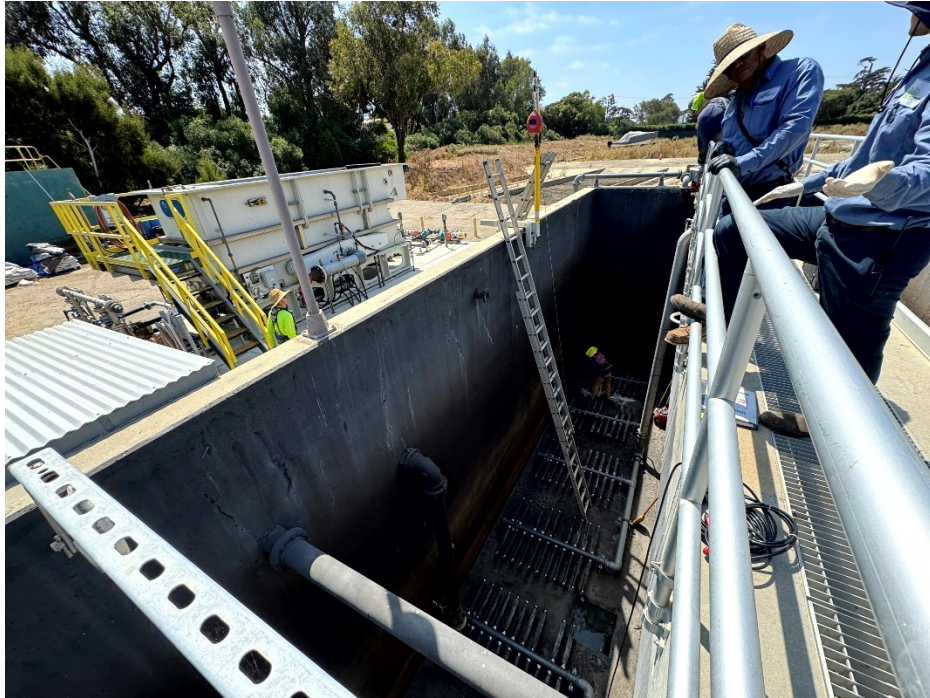
Figure 15

**Slab:** During the observation, the bottom of the slab had dry sludge making the entirety of the slab difficult to observe. The areas that were exposed were in generally good condition with minimal to no cracking.

The vertical crack plane that was present in the other concrete structures was not identified in the Aerobic Digester walls or slab.
